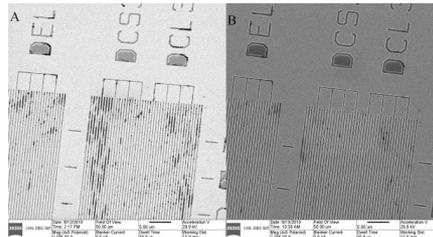
Figure 2: a) HIM image of old reticle before and b) after first 1 hour cleaning step

For our research we used a dummy reticle which consists of a TaN absorber, a SiO₂ buffer layer on a ULE substrate (see figure 1). The reticle did not have a EUV reflective multilayer coating, as we already have shown that multilayers are not affected by the plasma cleaning process. As the reticle was quite old we started with imaging the old reticle with our Helium Ion Microscope (HIM) to see what the present condition was. Immediately after the first image we treated the reticle for 1 hour with our plasma process. From figure 2 it can be clearly seen that most of the carbon contamination has been removed from the surface. Figure 3 shows the result on single lines and spaces on the same reticle.

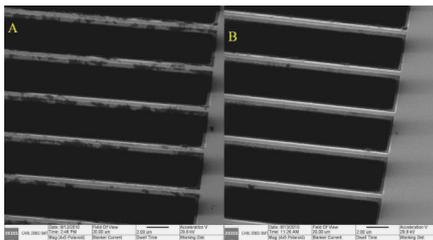
Figure 3: a) HIM image of single lines and spaces before and b) after first 1 hour cleaning step

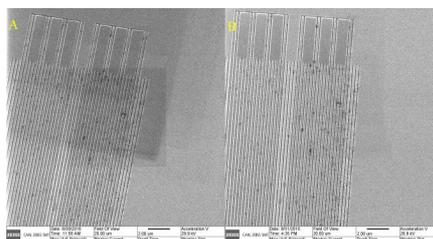
Figure 4: a) HIM image of single lines and spaces before and b) after first 10 min of cleaning

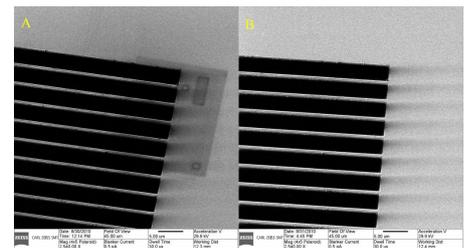
Figure 5: a) HIM image of SEM deposited carbon and b) the same image after 10 min plasma treatment

In order to verify if the reticle was not damaged we analyzed the absorber layer and the bottom of the trench with SEM EDX micro analysis. Results show that the material is not modified by the plasma. As a result of the micro analysis some carbon contamination with an approximate thickness of 2 nm was deposited on the reticle. To investigate the cleaning rate we exposed the reticle for 10 min to the plasma and imaged the reticle with HIM. The results of this cleaning action can be seen in figure 4 and 5. We removed almost all the carbon except for 1 area, which shows some slight signs of carbon contamination. After one additional treatment for 10 min with plasma the area has no traces of carbon left.

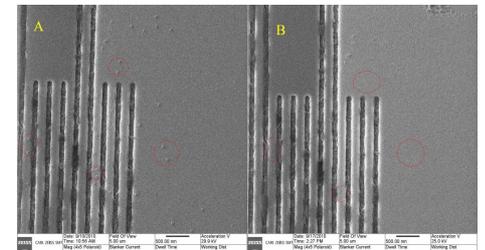
Figure 6: a) HIM image of reticle with 50 nm PSL spheres before and b) after 10 min plasma treatment

Finally we coated the reticle with 50 nm PSL sphere. Again the reticle was exposed to plasma for 10 min and re-imaged. From figure 6 it can be seen that some particles completely disappeared and some particles have become a lot smaller. This clearly shows that organic particles can be removed using our plasma process.
