# Development of beta EUV blanks at HOYA

Blanks Div., R&D Center\*,  
HOYA Corporation

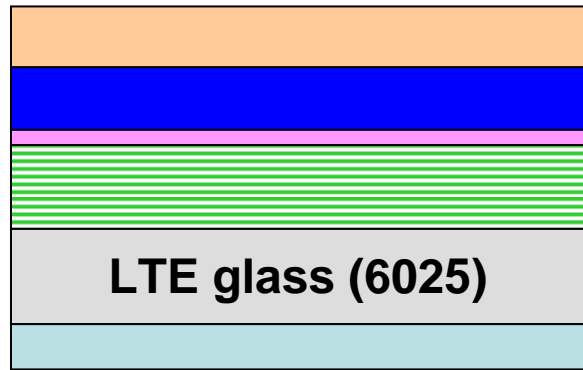
## 1. EUV blanks w/ buffer

1. EUV blanks consisting of CrN buffer and LR-TaBN absorber
2. EUV blanks consisting of Ru capping layer and LR-TaBN absorber

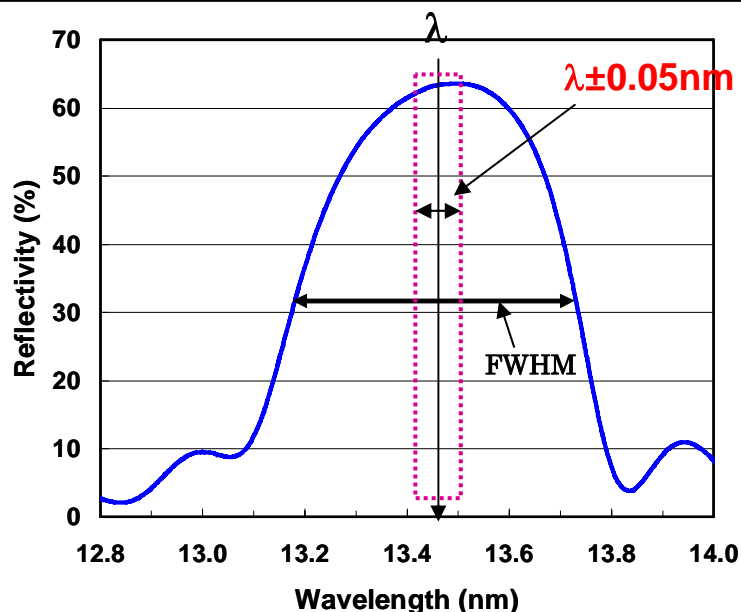
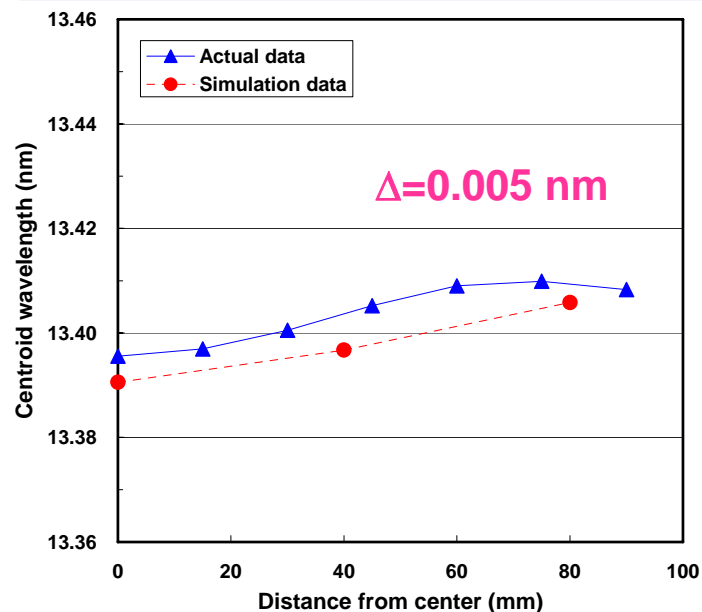
- Good agreement between actual data and simulation data
- Possible to manage centroid wavelength on ML using XRR

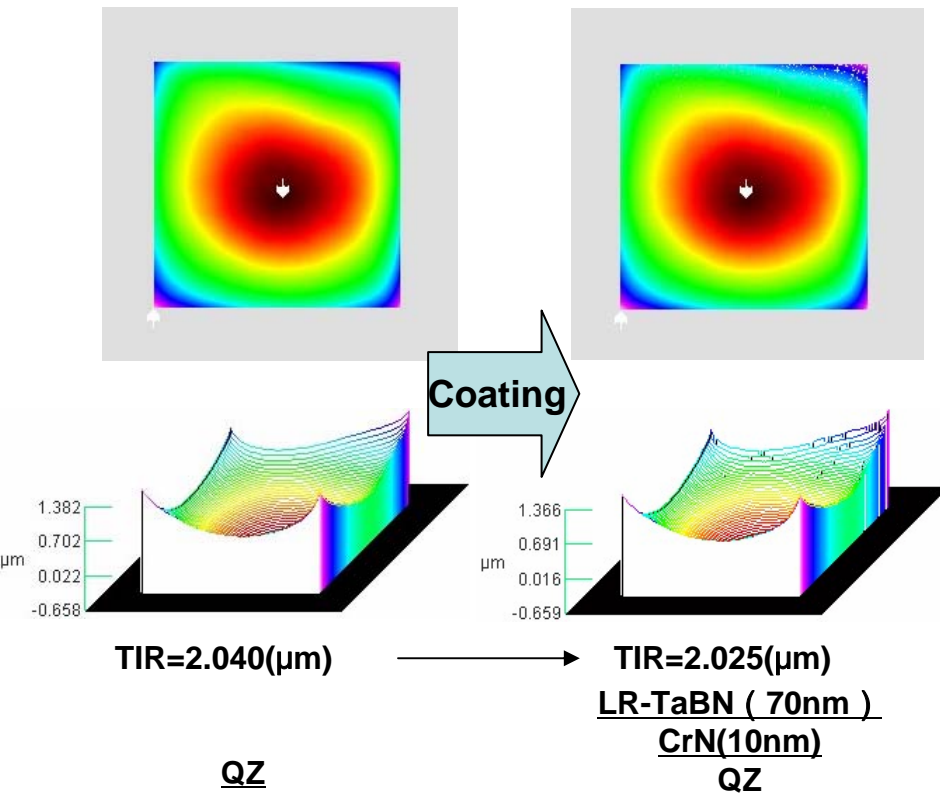
Low stress : <200MPa  
meeting SEMI spec.

Low defects at initial stage  
0def@150nm, 32def@80nm

LR-TaBN/CrN stacks with low stress and low defects demonstrated

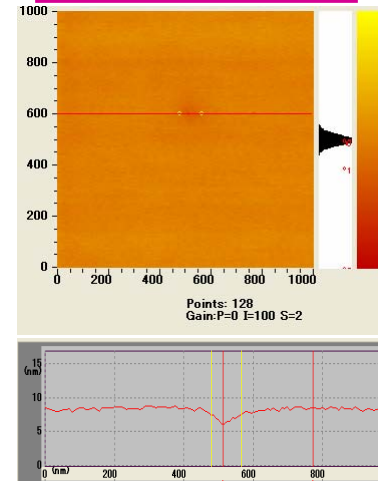
### M7360 inspection data\*

- ◆ M7360 inspection tool (made by Lasertec) has higher sensitivity on ML film
- ◆ There are many small defects on current ML blanks
