EUV mask and blanks development at HOYA

Electronics Development Center, HOYA CORPORATION

HOYA EUV mask

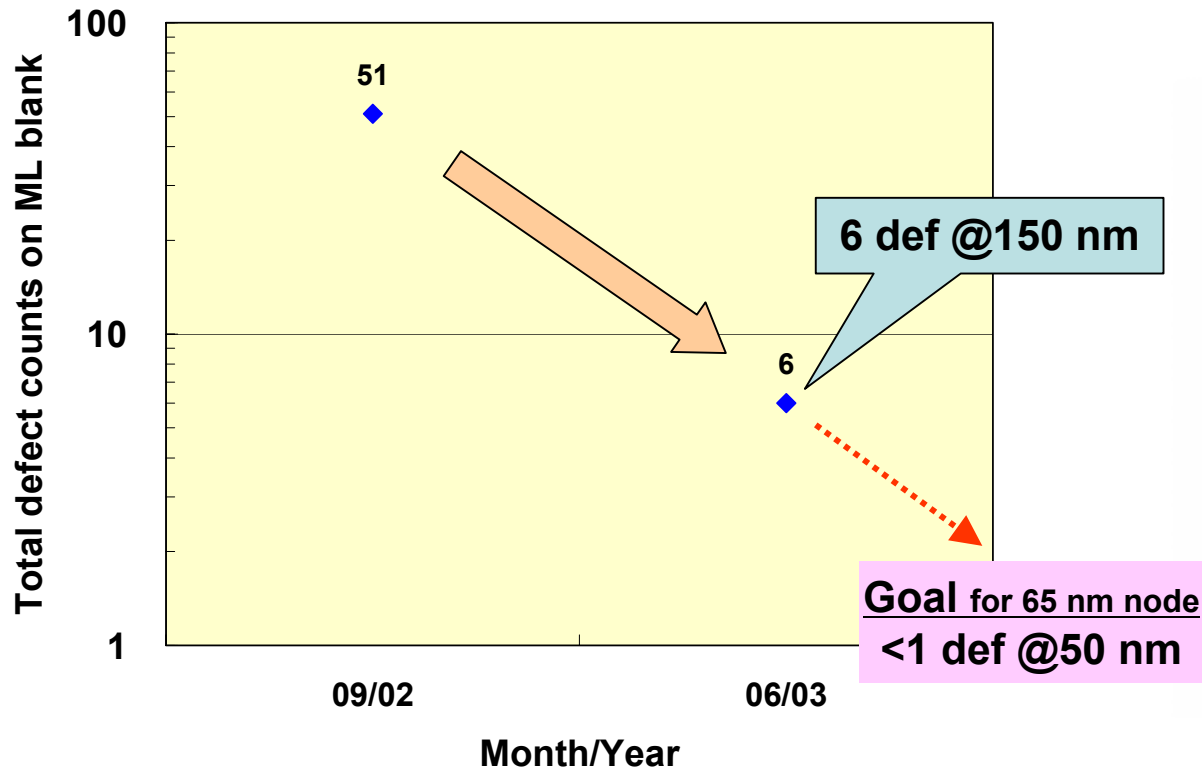
Fig. Progress in ML defect reduction

Total defects on ML blanks measured by M1320

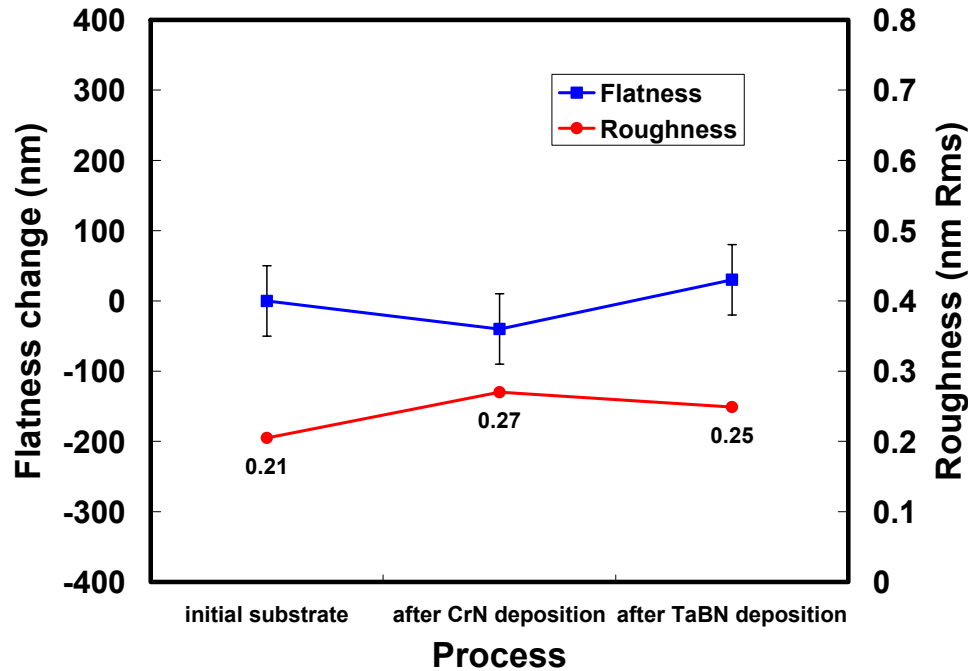
Fig. Flatness change in 142-mm sq. and roughness in 10 μm after CrN deposition and then after LR-TaBN deposition.

Low stress: <200 MPa
Smooth surface: 0.25 nm Rms

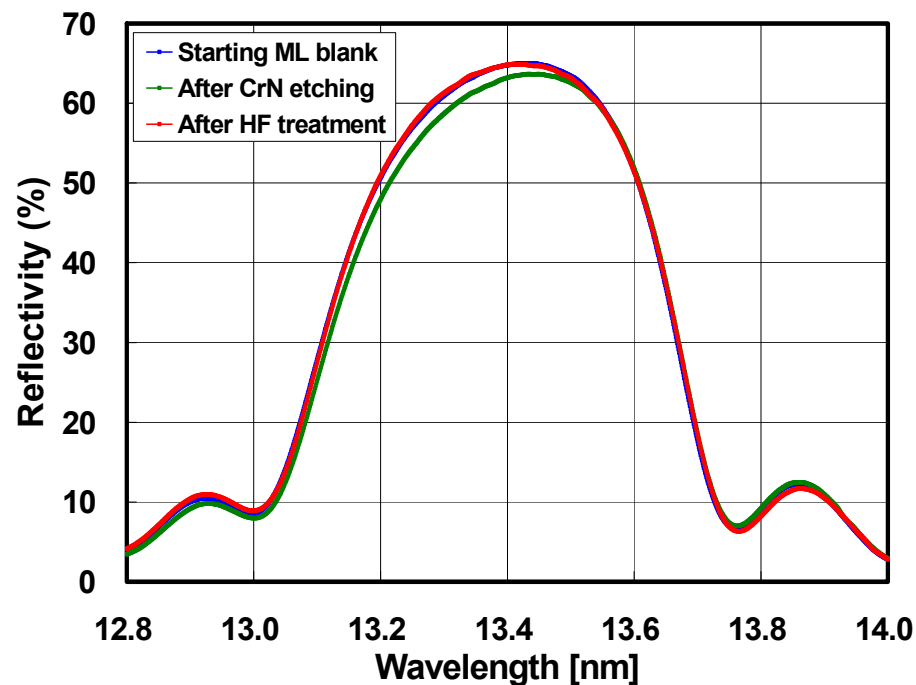
Fig. Reflectivity spectra for starting blank and mask after buffer layer etching and HF treatment.

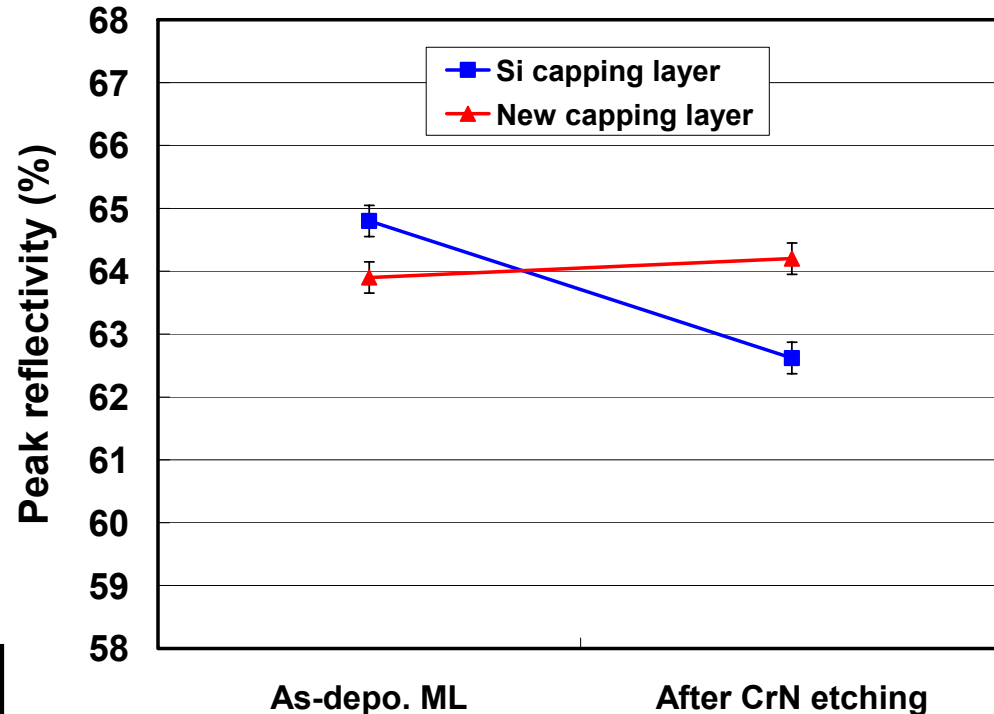
➡ EUV mask with new capping layer showed no change in reflectivity after CrN etching process.

Fig. Peak reflectivity of ML with Si cap layer and ML with new cap layer before and after CrN etching.

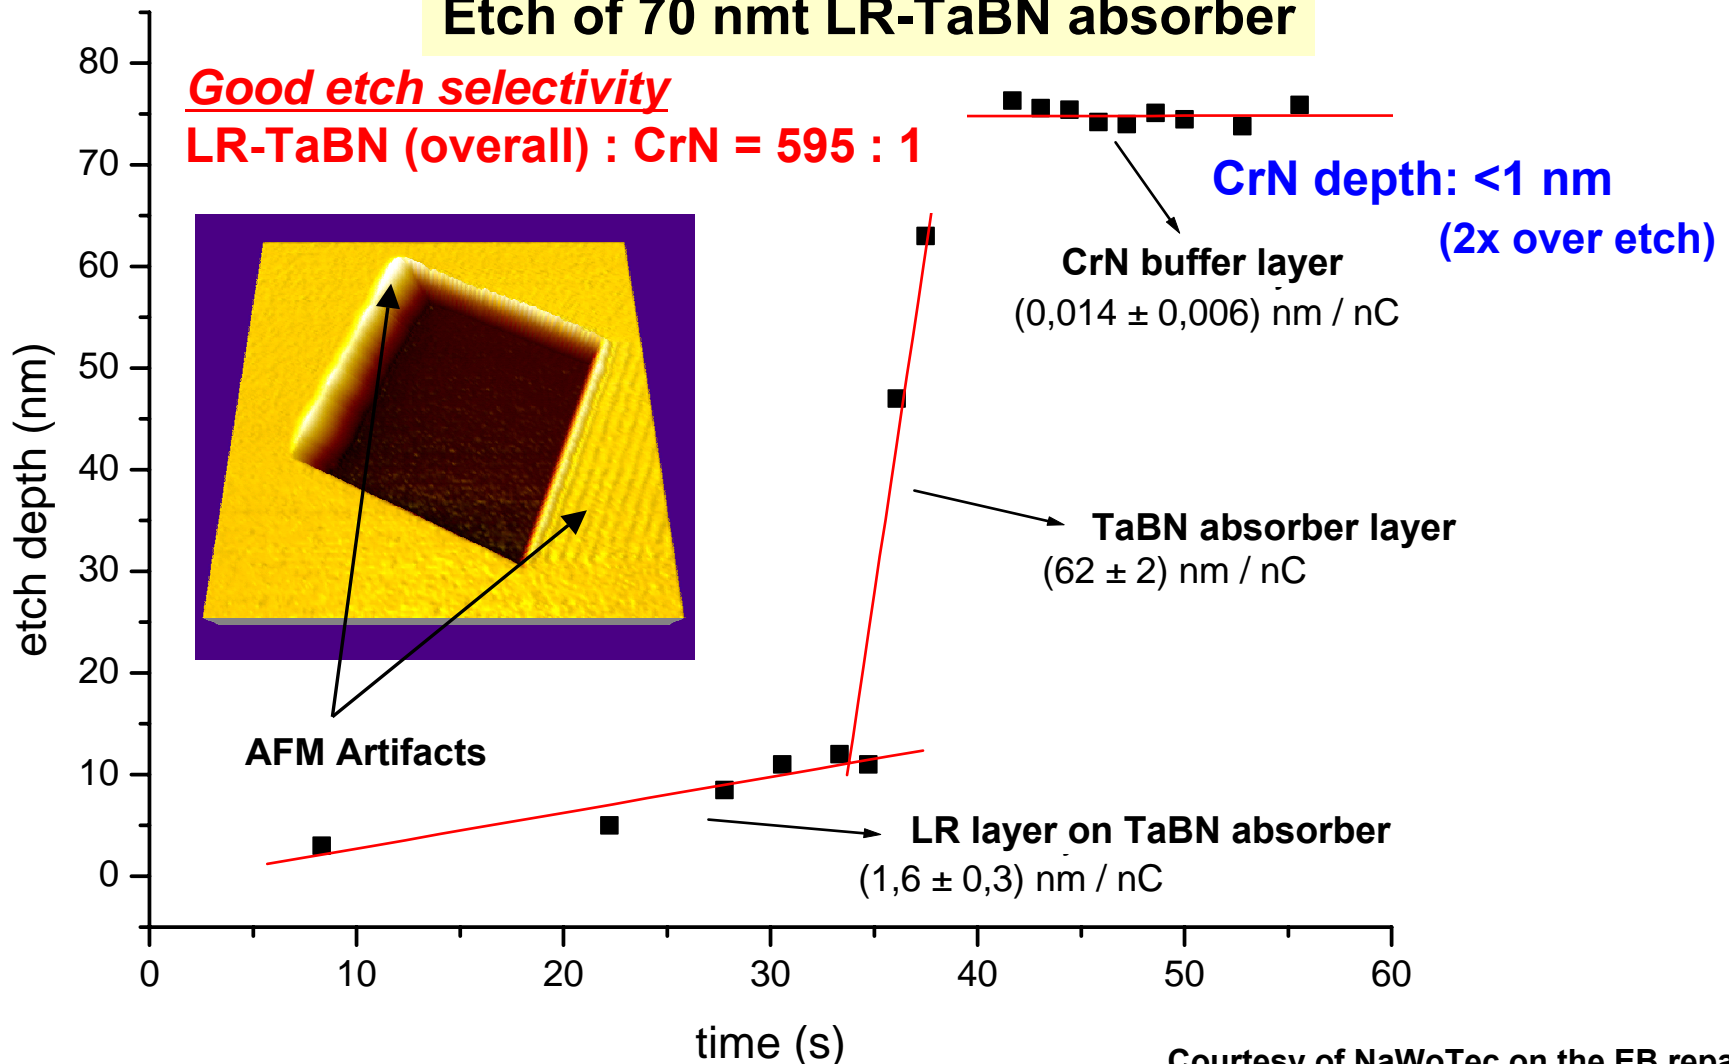
Etch of 70 nmt LR-TaBN absorber
